LAKE ASBURY DAM  
CLAY COUNTY, FLORIDA  
INVENTORY NUMBER FL 150

PHASE 1 - INSPECTION REPORT  
NATIONAL DAM SAFETY PROGRAM

PREPARED BY  
DEPARTMENT OF THE ARMY  
JACKSONVILLE DISTRICT, CORPS OF ENGINEERS  
JACKSONVILLE, FLORIDA

JULY 1978

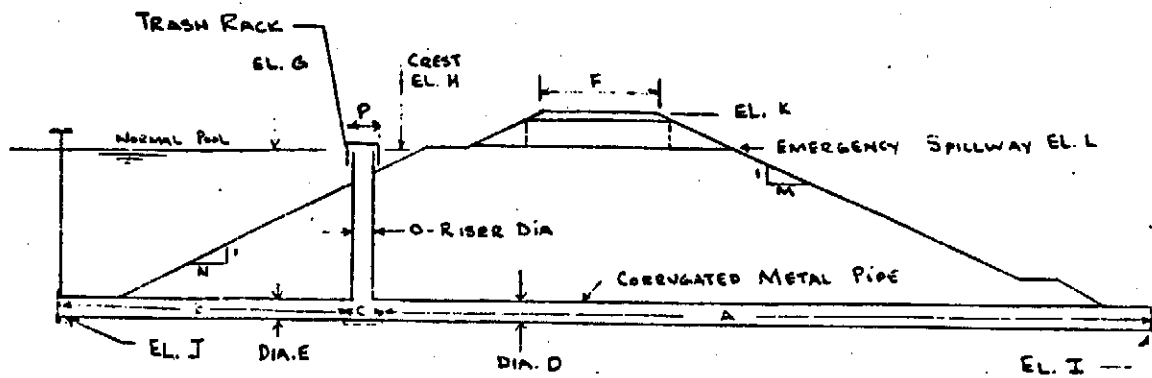
TYPICAL OUTLET DETAIL

(2) Drop-inlet Culverts. The two culverts are alike. Pertinent dimensions are shown on plate 3. At the downstream end of the northeast culvert, a timber support had collapsed and the pipe lay on the ground. The resulting slight bend in the c.m. pipe did not appear to be detrimental. Local residents said that the vertical slide gate at the upstream end of the culvert had been removed for repair and temporarily replaced with a cone plug. At the time of the inspection, the pool water level was 0.67 feet below the normal elevation of 25. That was due to discharge controlled by the slide gate of the culvert near the southwest end of the dam. At that culvert, no defects were noted. Both culverts appeared to be in satisfactory condition.

(3) Drop-inlet Culverts. A floating debris barrier encompassing the existing trash rack and extending about 10 or 15 feet from the riser could be constructed at each culvert. That would increase the probability that the culverts would perform adequately during floods.
