**LAKE RYAN DAM  
CLAY COUNTY, FLORIDA  
INVENTORY NUMBER FL 151**

**PHASE 1 - INSPECTION REPORT  
NATIONAL DAM SAFETY PROGRAM**

**PREPARED BY  
DEPARTMENT OF THE ARMY  
JACKSONVILLE DISTRICT, CORPS OF ENGINEERS  
JACKSONVILLE, FLORIDA**

**JULY 1978**

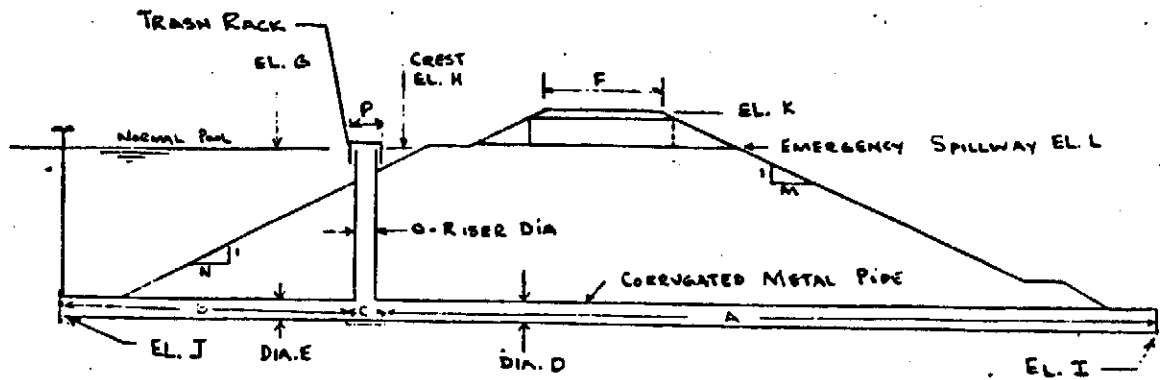
TYPICAL OUTLET DETAIL

c. Drop-inlet Culvert. The drop-inlet culvert, together with its slide gate, provides the only reservoir outlet. Pertinent dimensions are shown on plate 3. At the time of the inspection, the upper pool was about at its normal 50-foot elevation. That stage was controlled by the overflow riser, which appeared to be in satisfactory condition. The downstream end of the culvert was submerged and, therefore, not visible for inspection.

e. Drop-inlet Culvert. The culvert seemed to be functioning adequately. The overflow riser appeared to be in satisfactory condition. The downstream end of the culvert was submerged.

(2) Drop-inlet Culvert. A floating debris barrier encompassing the existing trash rack and extending about 10 or 15 feet from the riser could be constructed. That would increase the probability that the culvert would perform adequately during floods.
