**LAKE RYAN DAM  
CLAY COUNTY, FLORIDA  
INVENTORY NUMBER FL 151**

**PHASE 1 - INSPECTION REPORT  
NATIONAL DAM SAFETY PROGRAM**

**PREPARED BY  
DEPARTMENT OF THE ARMY  
JACKSONVILLE DISTRICT, CORPS OF ENGINEERS  
JACKSONVILLE, FLORIDA**

**JULY 1978**

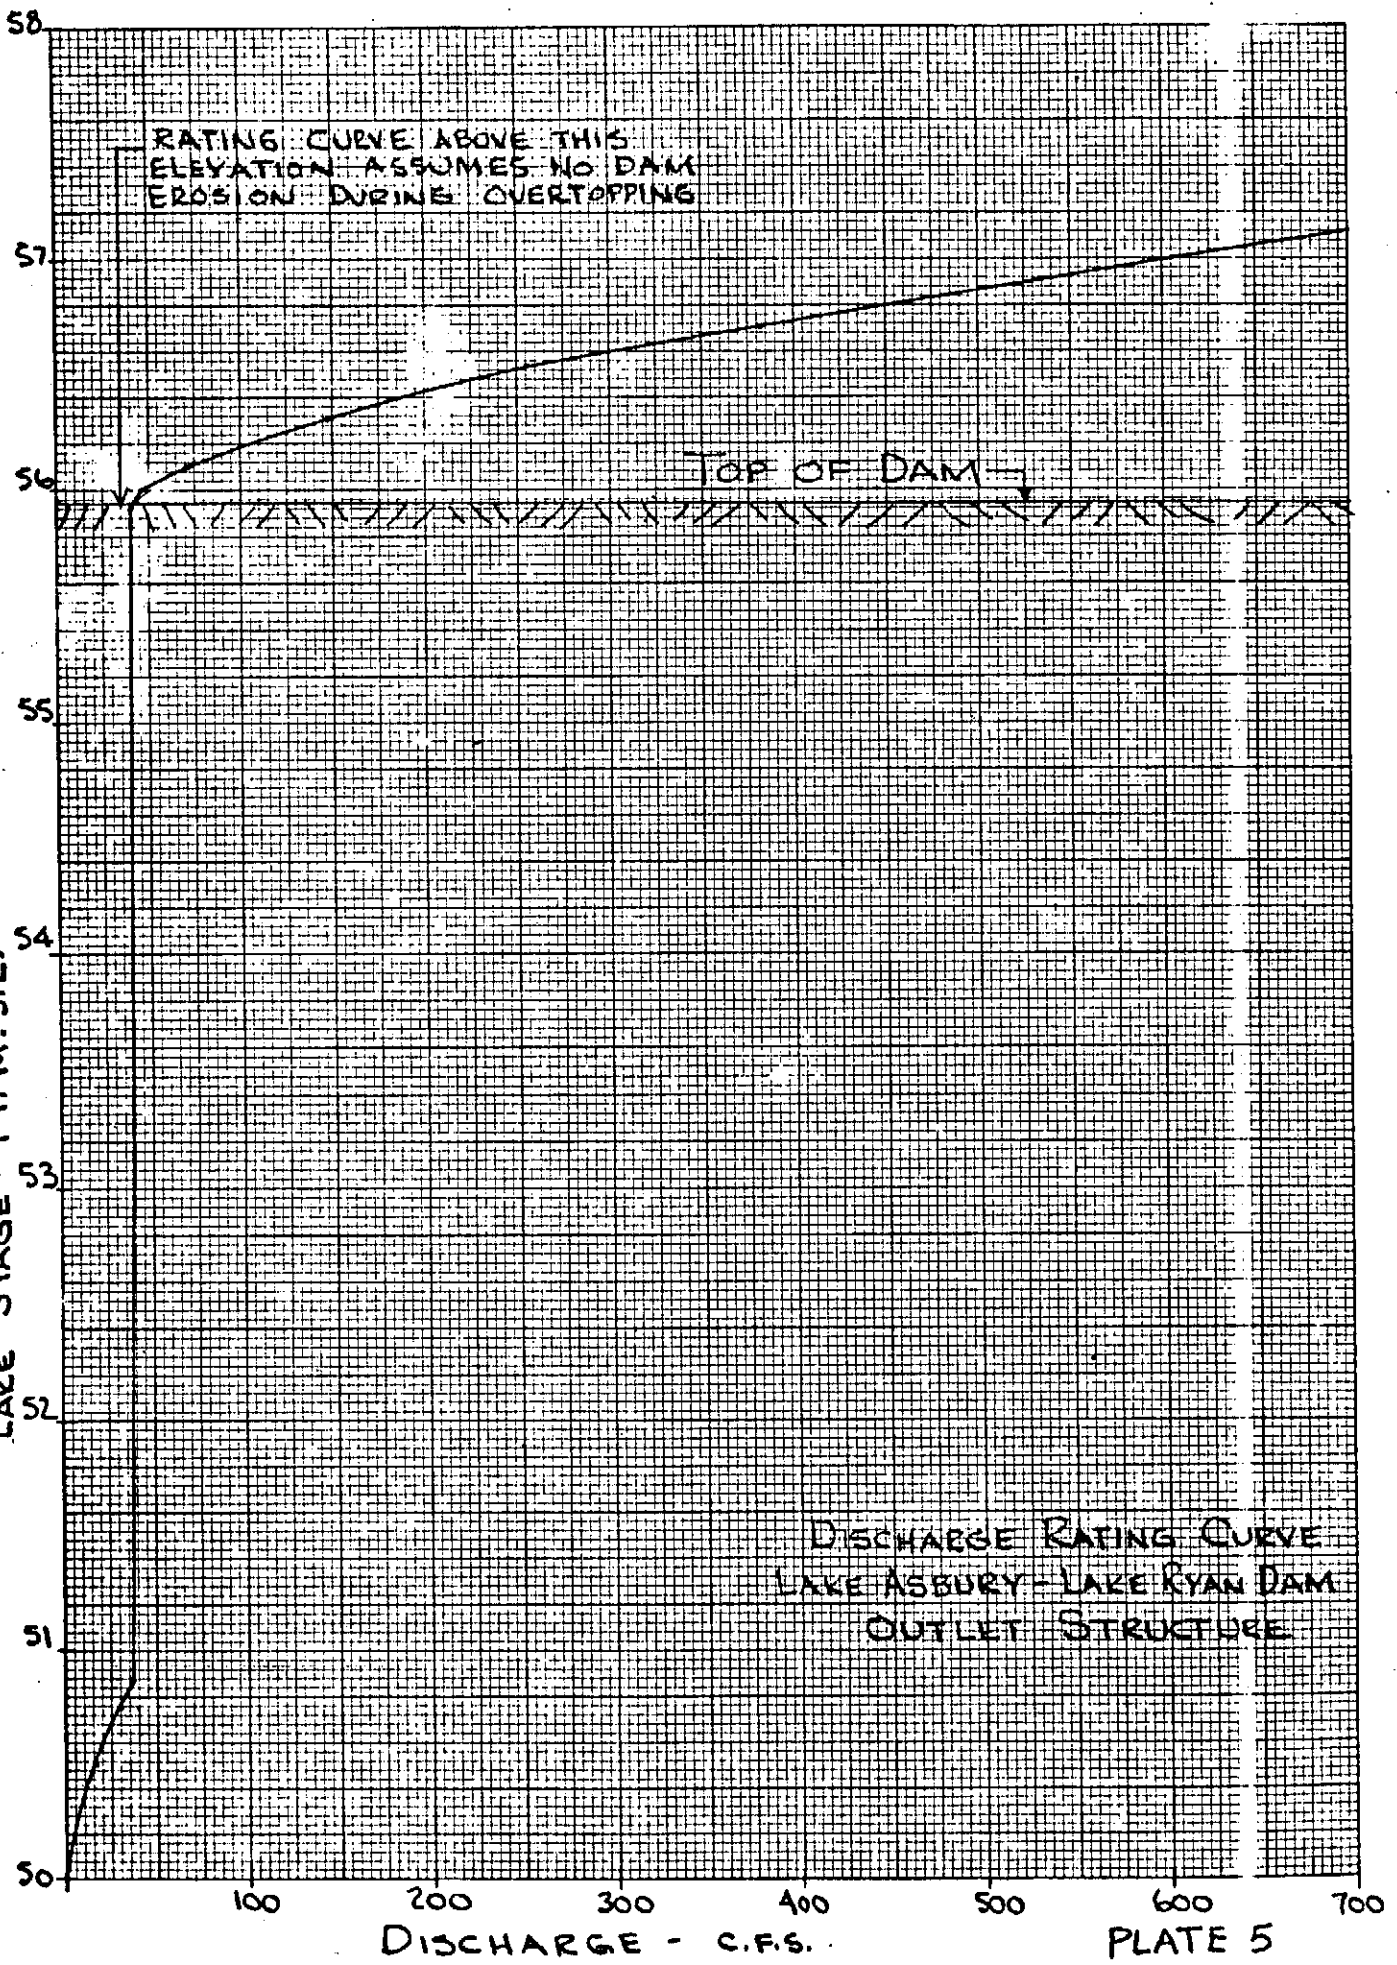
PLATE 5

(3) Discharge Rating Curve. A discharge rating curve for the outlet structure was not available. A curve developed by district personnel is shown on plate 5.
