**SOUTH LAKE ASBURY DAM
CLAY COUNTY, FLORIDA
INVENTORY NUMBER FL 153**

**PHASE 1 - INSPECTION REPORT
NATIONAL DAM SAFETY PROGRAM**

**PREPARED BY
DEPARTMENT OF THE ARMY
JACKSONVILLE DISTRICT, CORPS OF ENGINEERS
JACKSONVILLE, FLORIDA**

JULY 1978

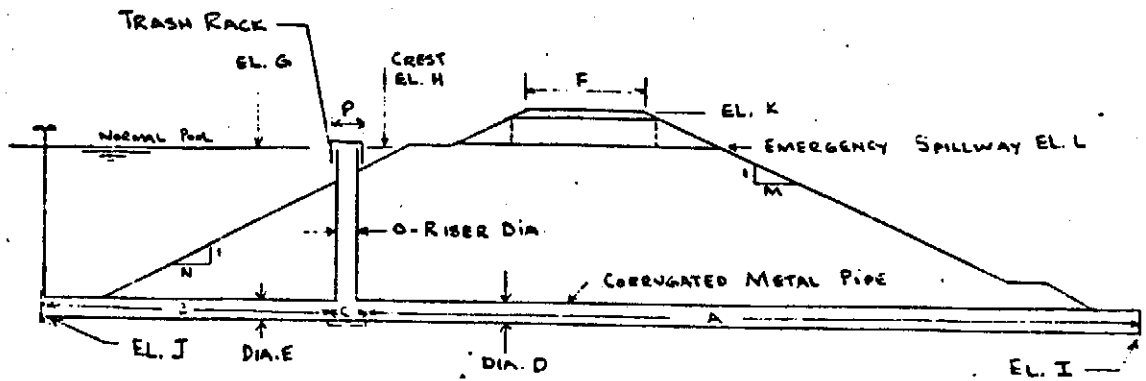
TYPICAL OUTLET DETAIL

* DIMENSION		NORTH DAM	SOUTH DAM	LAKE LARC DAM	LAKE RYAN DAM
SYMBOL	DESCRIPTION				
A	LENGTH OF PRIMARY CULVERT - FT	170	160	80	120
B	LENGTH OF DRAWDOWN CULVERT - FT	63	60	39	65
C	TRANSITION - FT	10	10	10	10
D	DIA. OF PRIMARY CULVERT - INCHES	24	36	30	24
E	DIA OF DRAWDOWN CULVERT - INCHES	24	30	30	24
F	TOP WIDTH OF DAM - FT.	38	37	29	23
G	NORMAL POOL EL. FT. M.S.L.	25	45	39	50
H	RISER CREST EL. FT. M.S.L.	25	45	30	50
I	DOWNSTREAM CULVERT INVERT - FT. M.S.L.	1.0	22	24	27
J	UPSTREAM CULVERT INVERT - FT. M.S.L.	2.0	23	25	28
K	EL. TOP OF DAM - FT. M.S.L.	29.1	49.0	42.1	55.9
L	EL. SPILLWAY CREST - FT. M.S.L.	25.9	—	—	—
M	DOWNSTREAM EMBANKMENT SIDE SLOPE	3	3	2.5	2
N	UPSTREAM EMBANKMENT SIDE SLOPE	3	3	2.5	—
O	DIA. OF RISER PIPE - INCHES	42	66 TO 48	54	60
P	DIA OF TRASH RACK - INCHES	72	108	72	84
	LENGTH OF DAM - FT	1600	950	250	250
	HEIGHT OF DAM - FT	31	30.5	20	29

* DIMENSIONS AND ELEVS SHOWN ARE APPROXIMATE AND ARE BASED ON FIELD OBSERVATIONS OR ESTIMATES.

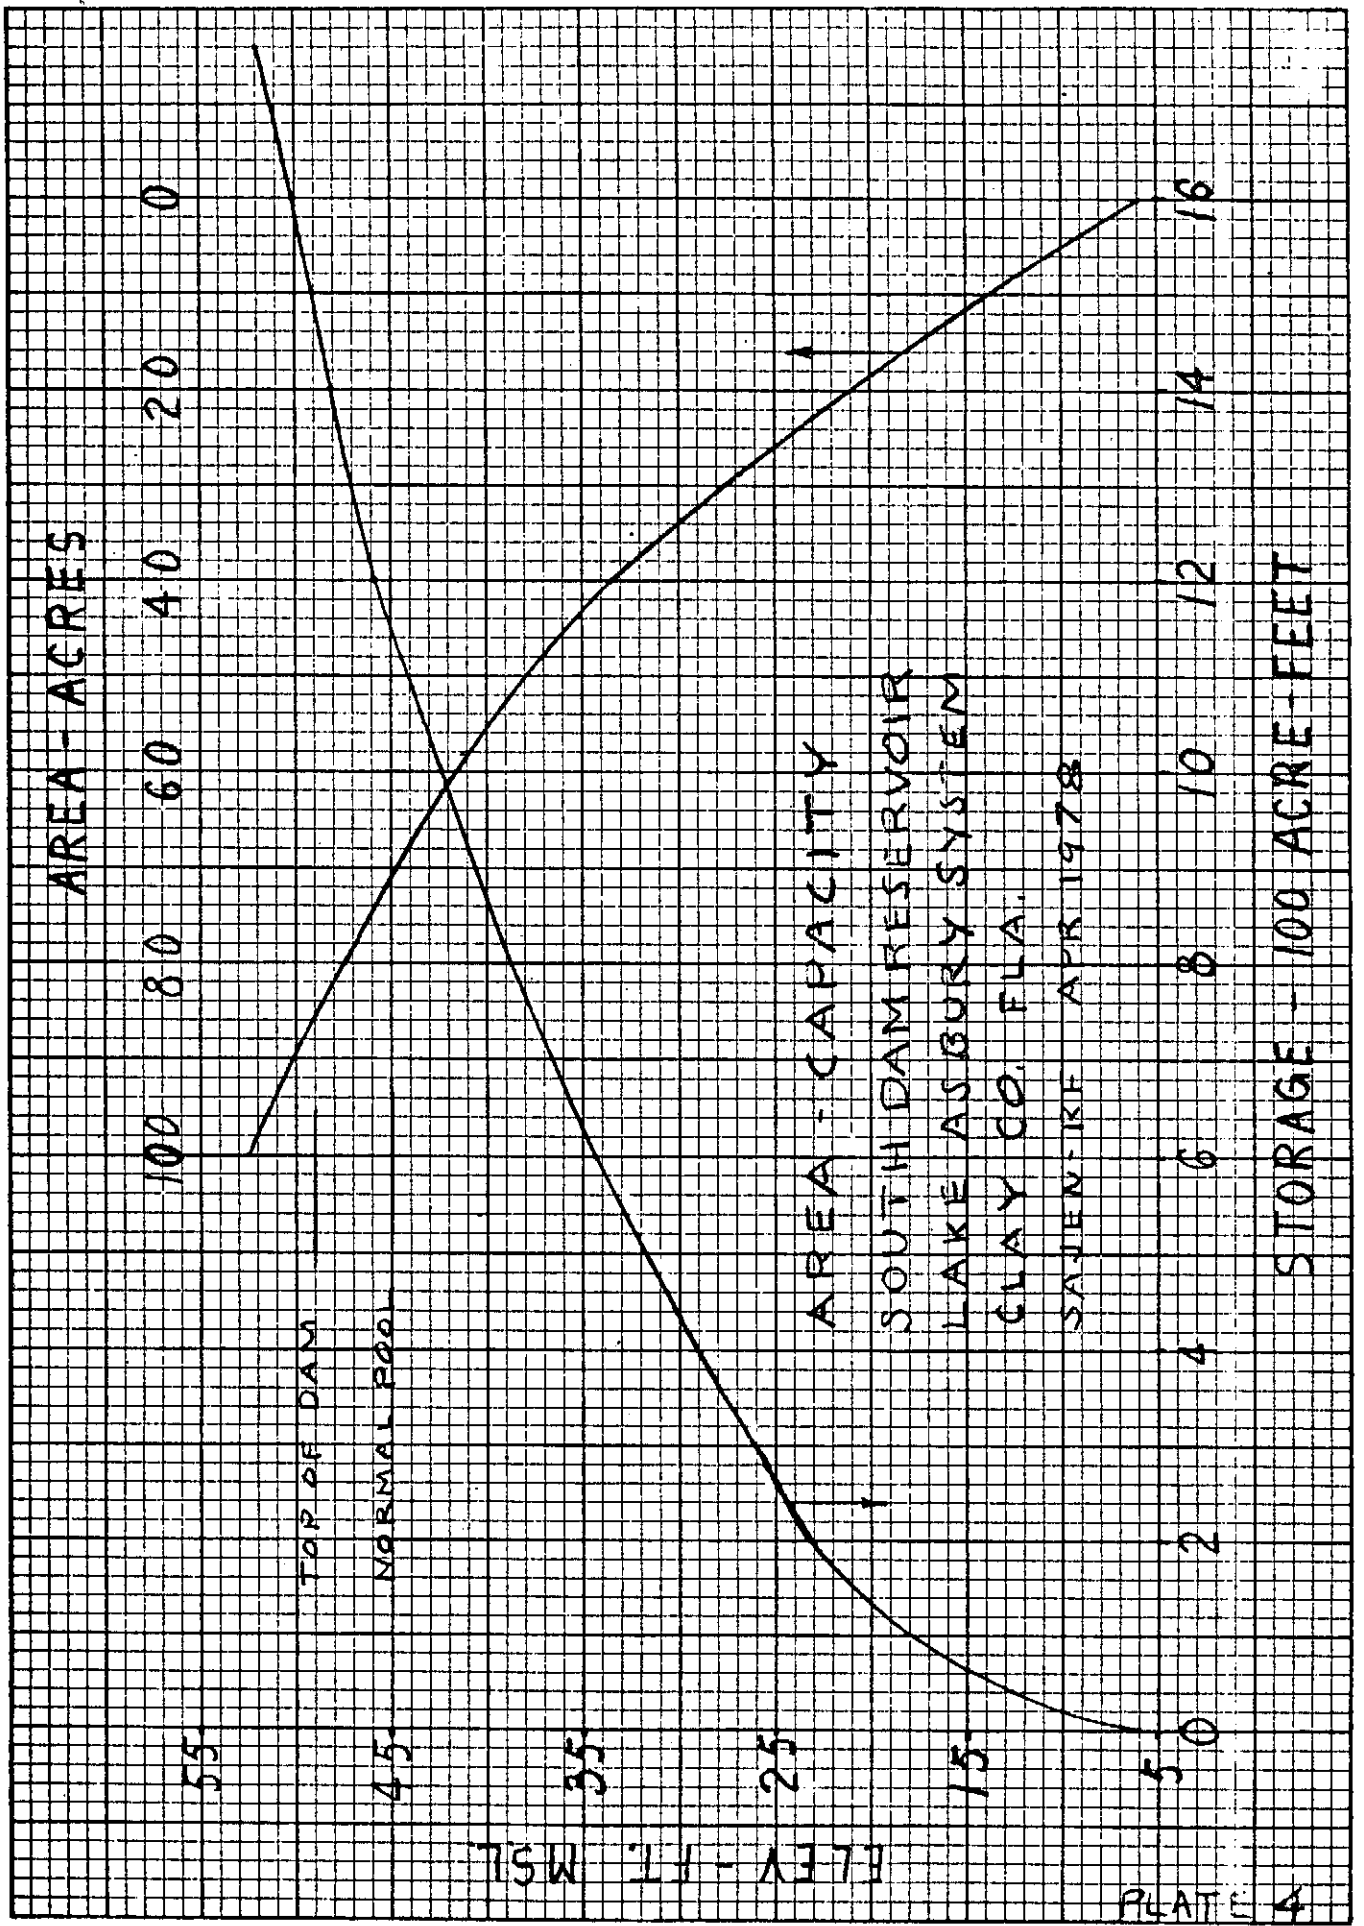
AREA - CAPACITY
SOUTH DAM RESERVOIR
LAKE ASBURY SYSTEM
CLAY CO. FLA.

STORAGE - 100 ACRE- FEET
